## SLIPWAY REPAIR / REPLACEMENT?

By Geoff Wallbridge, Chairman D.A.P

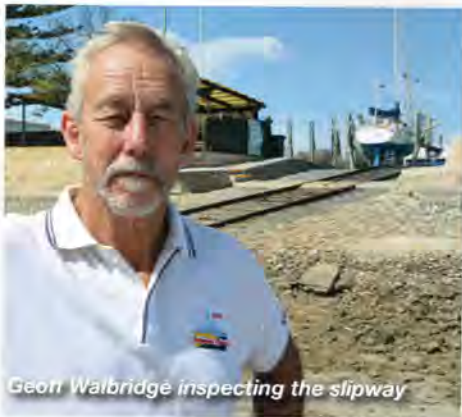
Geoff Wallbridge inspecting the slipway

**There have been a number of derailing incidents over the years in which cradles have de-railed while lifting vessels out of the pool on our slipway.**

Lloyd Cushway dived on the underwater parts of the slipway a number of times and produced a detailed set of measured drawings which showed that the slipway suffers from several defects.

- The connection between the main structural beam on the western side, has

a very poor connection to the western steel pile which supports its outer end.

- The gauge between the two rails of the slipway varied considerably and significantly, in places, was 30+mm over the standard dimension.
- The whole original structure had been over-laid with a second structure and rails, which had been slid down on top of the old rails. This created a slightly top heavy and unstable structure.
- The head of the rails, in the inter-tidal zone where the load of boat and cradle starts to bear on them, had worn away from about 50mm thickness to 10mm; drastically weakening them.

About a year ago the DAP organised diver Jock Laurie to install a number of tie rods across the upper rails and lighten them up in an attempt to maintain the correct gauge. This was partially successful but in places the rails refused to move inward and some infrequent derailments continued to occur.

Recently the RSAYS maintenance staff have reduced the allowable gauge tolerance in the wheels of two of the cradles and this seems to have overcome the immediate problem of derailments.

- Option 1 – replace existing upper rails
- Option 2 – replace whole slipway
- Option 3 – new vertical shiplift with winches and cables
- Option 4 – new vertical shiplift with hydraulics

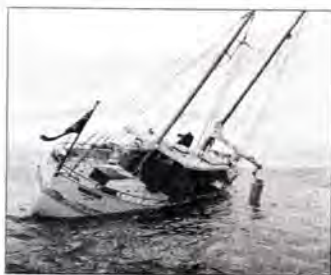
**■ HIGH AND DRY...** The Mameena ran aground on Troubridge Shoal, near Edithburgh, at 8.30am last Thursday, January 22.

Mr William-Smith accompanied divers from Adelaide-based Lawrie Commercial Diving as they did an initial inspection of the boat, which is leaning over at 42 degrees, the next day.

"There is no visible damage, after all she weighs 65 tonnes and is 56-foot long, so she's a tough old boat," he said.
